# Diamond-Coated Versus Conventional Bits for Rotary Cutter Head Equipment

by Roy L. Campbell, Sr., G. Sam Wong

Final report

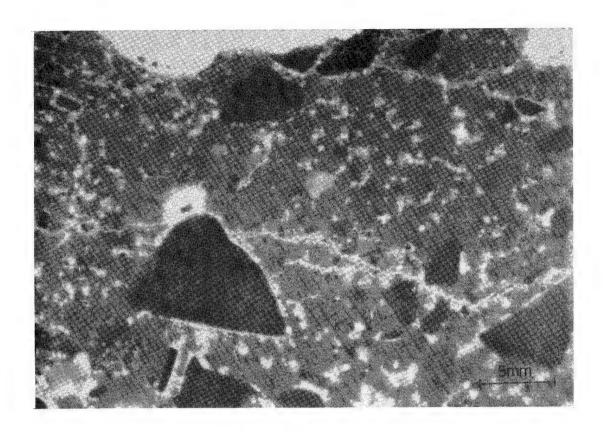
Figure C3. Specimen 930246. Fracturing of smaller aggregates is evident in the upper center of micrograph. 4X
